HANCE PAVILION ASSESSMENT FOR CITY OF PIQUA

May 19, 2023

FREYTAG & ASSOCIATES INC.
ARCHITECTS ENGINEERS

Executive Summary

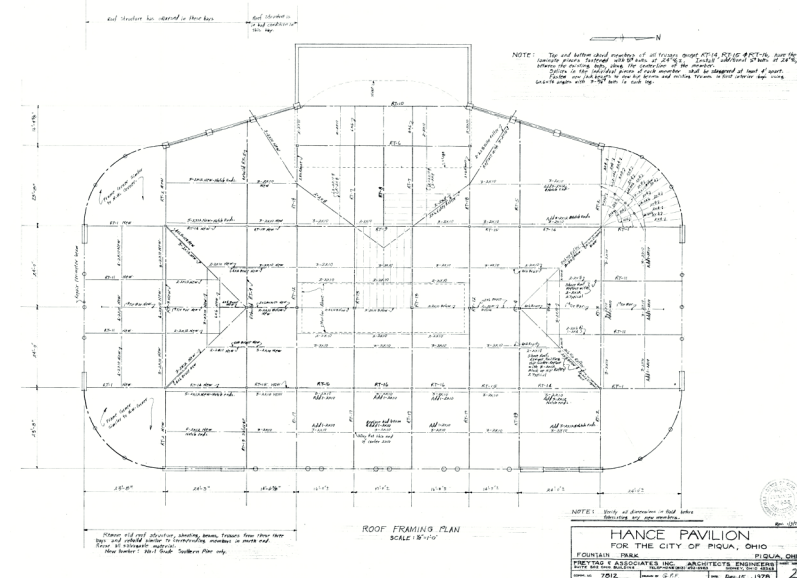
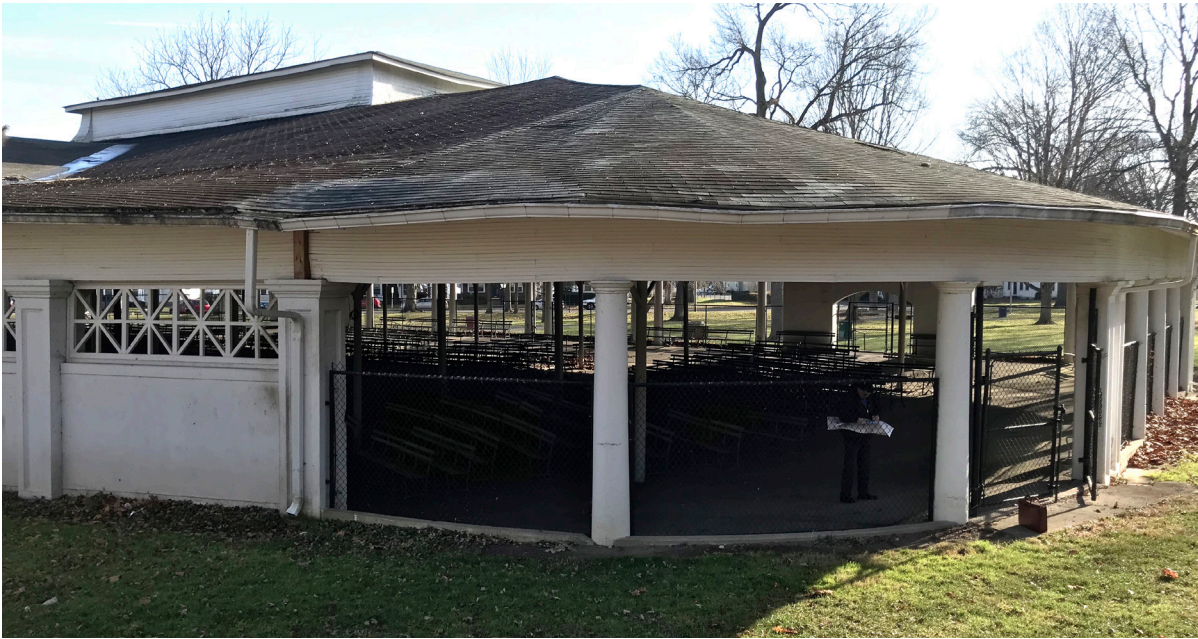
The Hance Pavilion is a rather complex shape being generally oval with the side behind the stage extended outward slightly to incorporate the dressing rooms spaces. The roof slopes outward to the perimeter on all sides with the pitch lightly changing over the run. There is a clerestory element at the center of the oval extending above the primary roof by four to six feet. At the present time, the sides of the clerestory are solidly sided but understand, through historic photographs, that the original construction might have had open sides to allow for natural ventilation during the summer months. The roof structure is constructed primarily of milled lumber pieces typically referred to as rough-hewn framing members. Due to previous repairs, there are nominal dimensional lumber members within the framing. The major framing members consist of site assembled, relatively deep trusses. There are several different shapes of truss depending upon their location within the structure. The trusses support wood beams and purlins that in turn carry the roof sheathing. The trusses are supported by solid wood or steel interior columns. The concrete walls/columns on the perimeter do not necessarily align with the truss locations indicating that the trusses frame to beams that are then spanning to the perimeter columns/walls. The dressing room spaces appear to be standard bearing wall construction using wood stud or masonry bearing walls. The roof framing over these spaces is standard rough-cut wood roof joists. In reviewing the 1978 renovation, it is clear that a significant amount of framing repair was completed. The repairs included corrections to the trusses, rafter/purlin replacement, sheathing replacement, and other modifications.

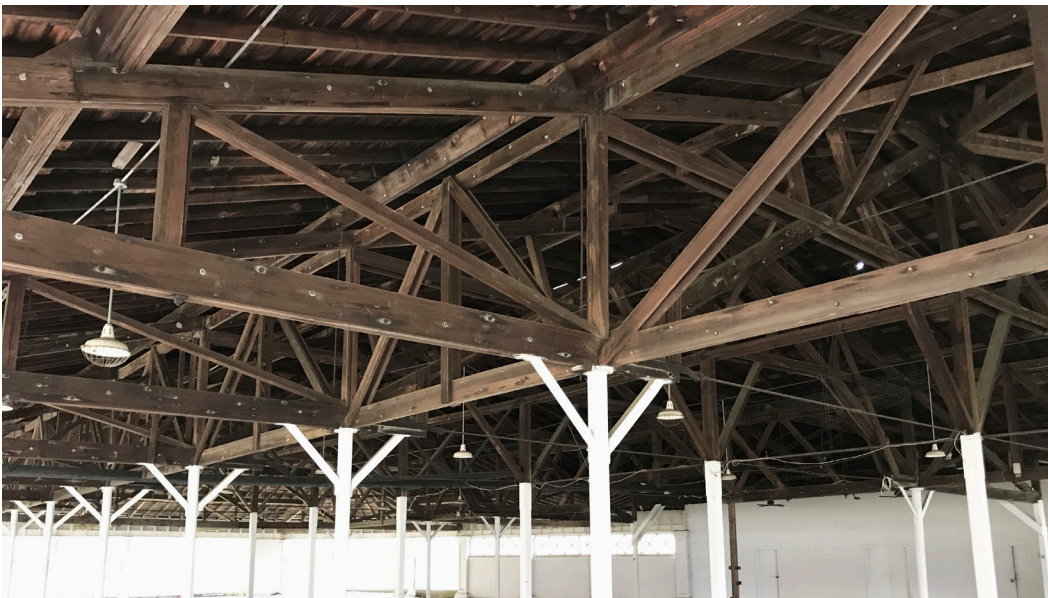
We observed that the building framing is generally in satisfactory condition overall considering age, use, and exposure. We noted that the roof slopes are no longer entirely without localized sagging and there are several of the ridgelines that seem to be “saddling”. There is generally isolated damage to the roof sheathing where roof leaks have led to water infiltration that has over time resulted in decay. In conjunction with these leaks, individual rafters/purlins have also been damaged to decay in some locations. At the time of our visit, there was limited evidence of active leakage. It is estimated that about five to ten percent of the roof sheathing will be found to be damaged to the point requiring replacement. It is estimated about five percent of the roof rafters/purlins/beams are likely in a state that replacement in kind would be seen as necessary.

The trusses generally seem to be sound, but several were seen to have loose or otherwise shifted joints indicating that movement or long-term shrinkage has led to changes in the way in which the truss functions to distribute and support loads. We noted some members of trusses being split or otherwise damaged. This mostly occurs on the south side of the pavilion. Interestingly, the trusses were strapped together using steel cables and bars and the repair drawings from 1978 show that some of the steel was reinforced as a part of that project indicating that the steel existed prior to 1978. It is unclear why the members were reinforced but it is likely a result of variations in design criteria as opposed to clear deficiencies in the framing. Nevertheless, the steel elements were also seen to be in need of remedial attention in the tightening of the connections and assemblies. It is believed that replacement of individual members of trusses can be accomplished as needed to correct the conditions. Where joints or steel elements need adjustment, that should be able to be completed with the truss left in place so long as the roof loading is shored at that time.

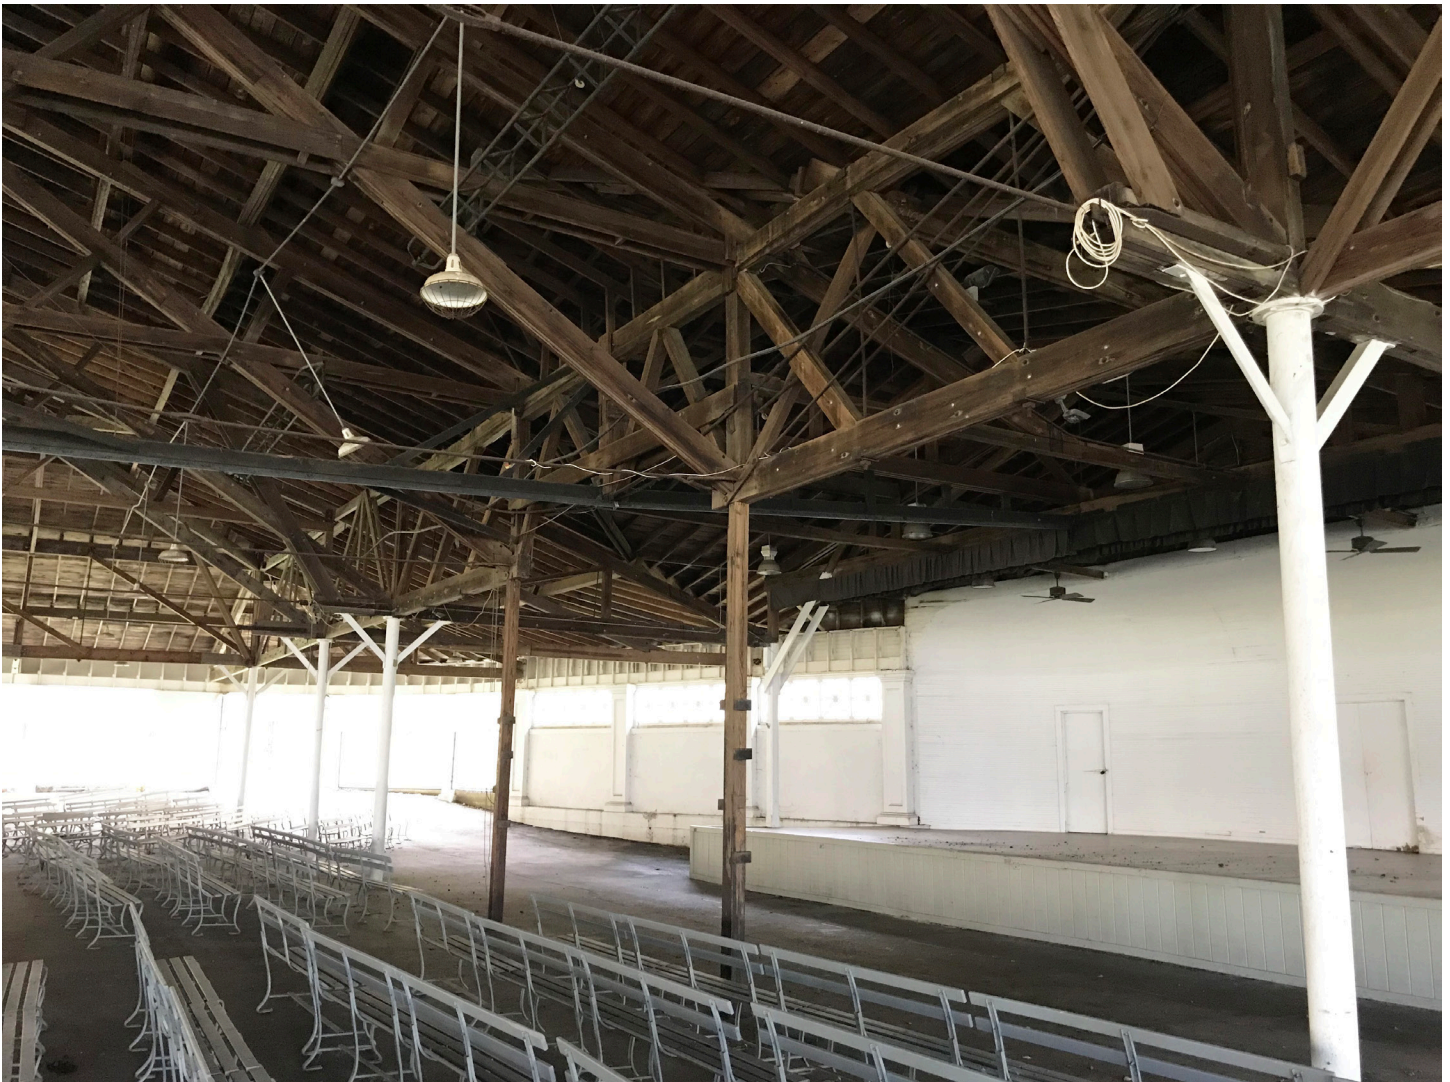
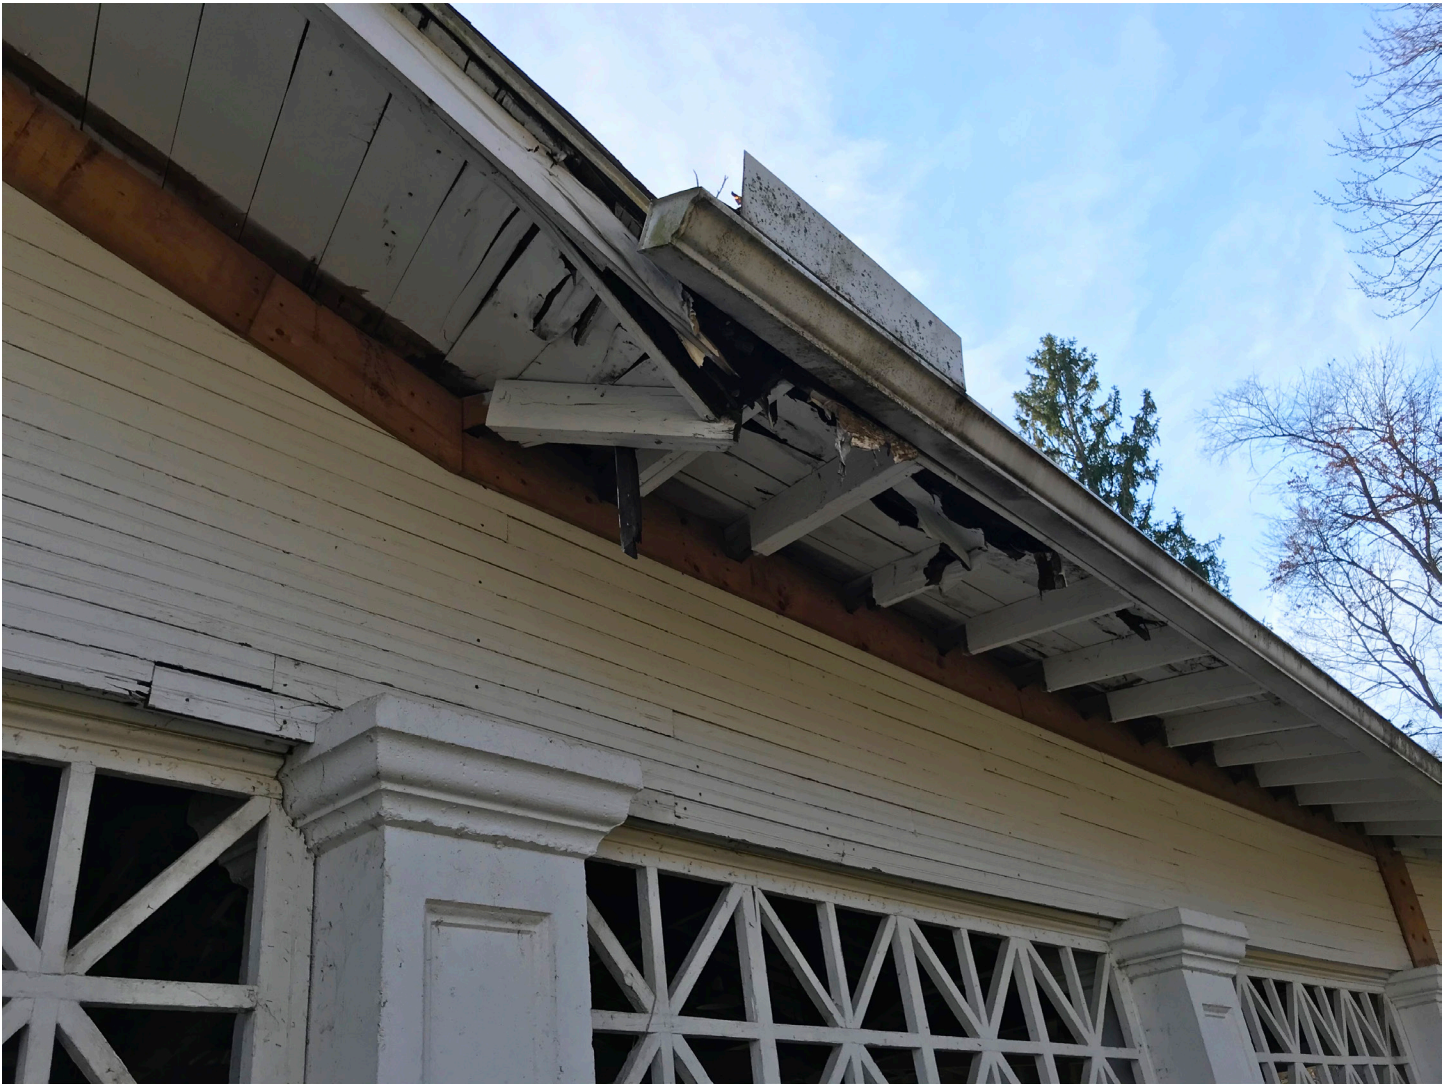
We found several of the interior wood columns to be bowed or otherwise out of plumb. Minor bowing or irregularity is not unusual in older wood framed structures but the extent in this case appears to warrant restoration. We suspect that those columns will require replacement to correct the outward appearance or structural capacity concerns.

Note that it is quite possible that these conditions have existed for a long period of time and therefore are mostly stable. They should however be addressed to prevent potential problems.

We find that the Hance Pavilion exhibits damage that might be expected for an exposed structure in which maintenance has been deferred over time. Fortunately, there are no indications at this time that the damage is severe enough that repairs would be impossible or overtly cumbersome to complete. It is accurate to state however that the structural repairs will be invasive and technically challenging in certain instances. For purposes of this report a range of magnitude cost for structure repair is included in Priority Work Opinion of Cost.

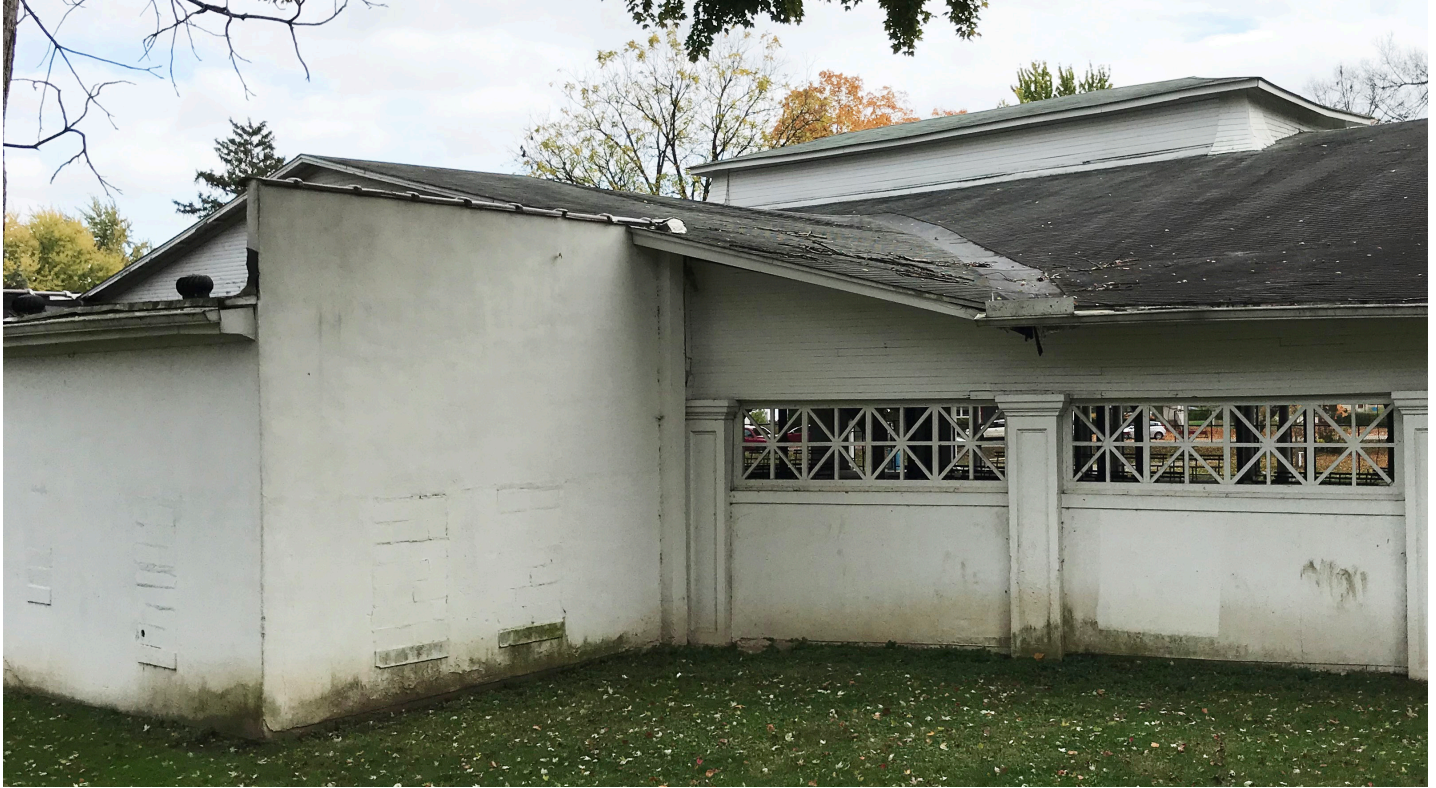
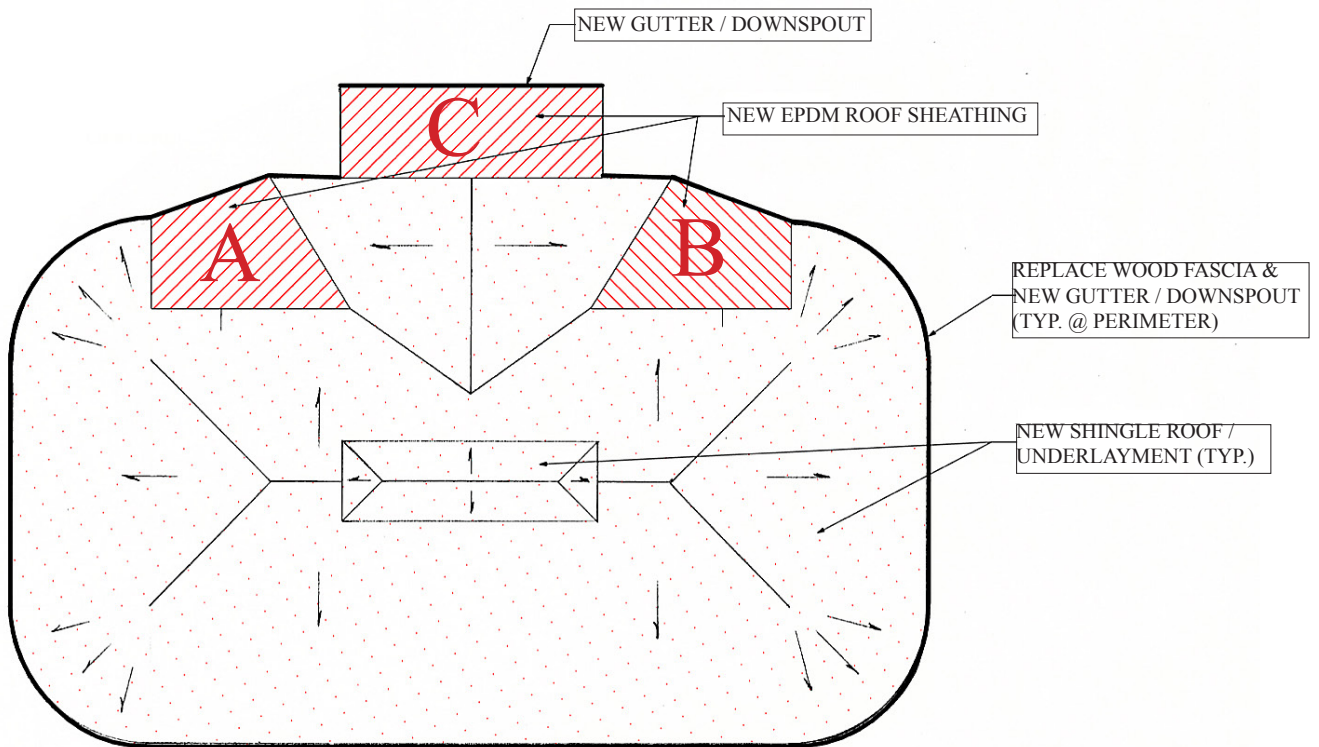
ROOF PLAN

Existing roof over the main structure consists of asphalt shingles over wood sheathing/wood structure over audience seating/stage and EPDM roofing over wood sheathing/wood structure above dressing rooms. The original roof covering over dressing rooms appears to have been a built up roof as evidenced on parapet walls. Both roof coverings are in poor condition and in need of replacement. Major deterioration has occurred at shingle roof over the low slope roof, areas A and B, on Roof Plan diagram. The wood sheathing in several areas appears to be deteriorated and for purposes of this report it is assumed 10% of the sheathing will be replaced. Existing gutter and downspouts are in poor condition and need to be removed and replaced. Masonry parapet wall has clay coping tile and is in fair condition.

Remove all existing roof coverings and deteriorated sheathing. Provide new sheathing, underlayment and new asphalt shingle roof over the main structure and clerestory. In low slope portion of the roof, areas A and B, provide adhered EPDM roof covering. Above dressing rooms, area C, provide new sheathing and adhered EPDM roof covering including flashing on parapet walls and new metal coping. Provide new metal gutter and downspout around perimeter of the structure. with downspouts to outlet directly in grass area.

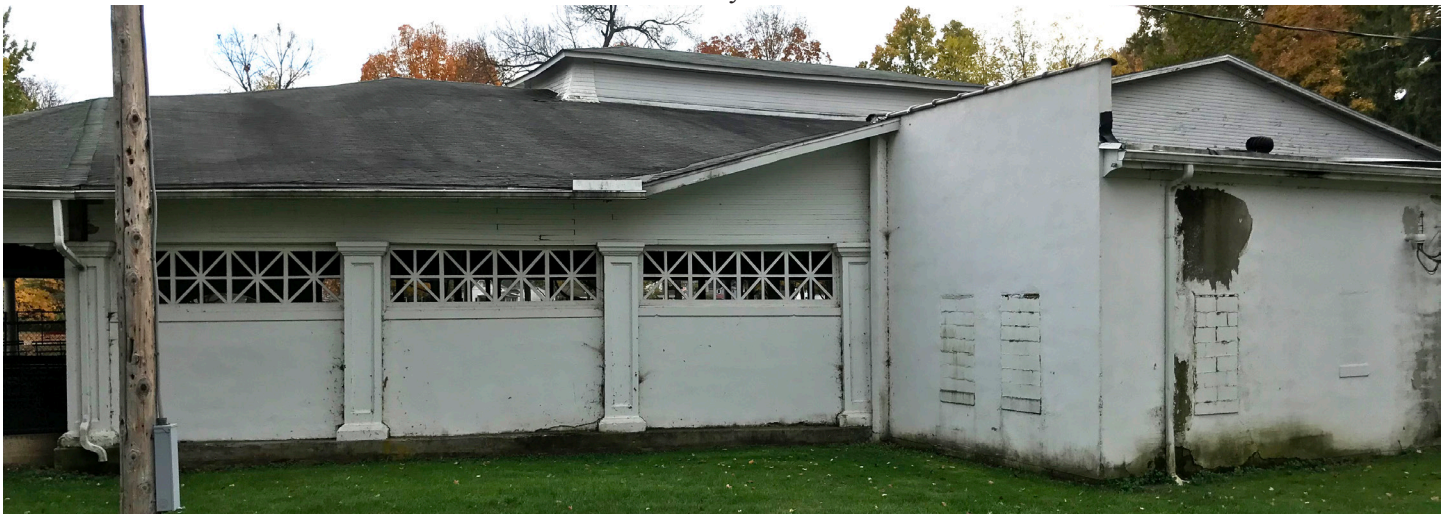
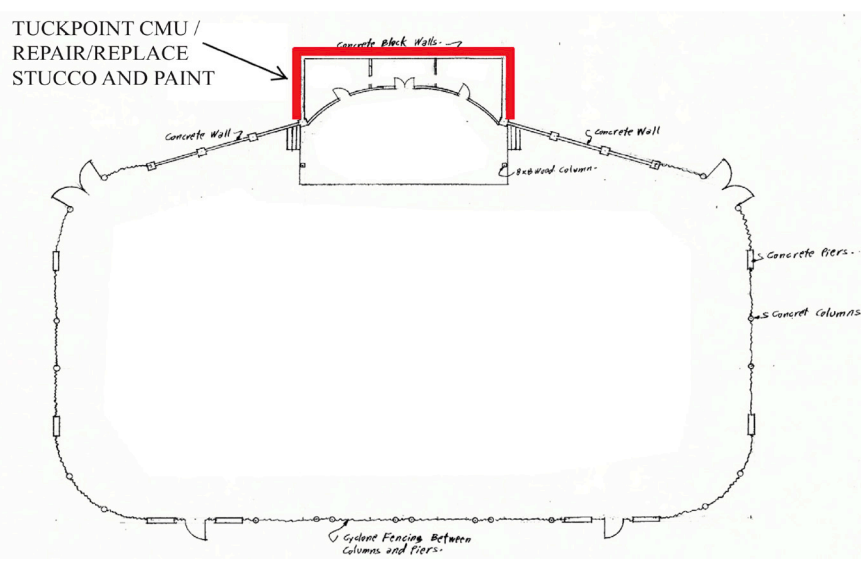
FLOOR PLAN

Perimeter of audience seating area is cast in place concrete walls/columns and are in generally good shape. Perimeter soffit/knee wall shows some movement as noted in the structural narrative. Interior/exterior wood siding is deteriorated in many areas and should be replaced. In addition, the top of the knee wall is open and provides nesting place for animals. Perimeter masonry walls at dressing rooms show damage from poor roof drainage, standing water at base of wall and water infiltration at locations of windows infilled with masonry.

Provide repairs per structural analysis including repair of wood siding on knee wall, new wood cap to close top of wall from animals and paint.

Tuckpoint masonry wall at infilled openings, remove loose paint, clean walls, provide stucco coat over existing masonry and paint. Regrade soil at base of wall to direct water away from foundation. If storm line exists near the pavilion, it is recommended to provide new perimeter roof drain line tied to existing storm line.

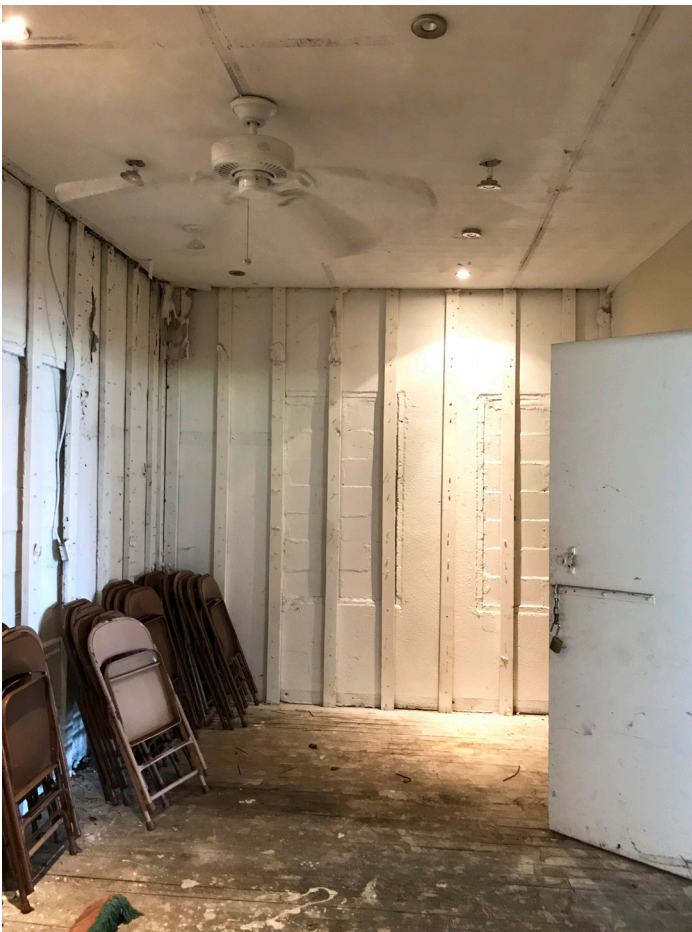
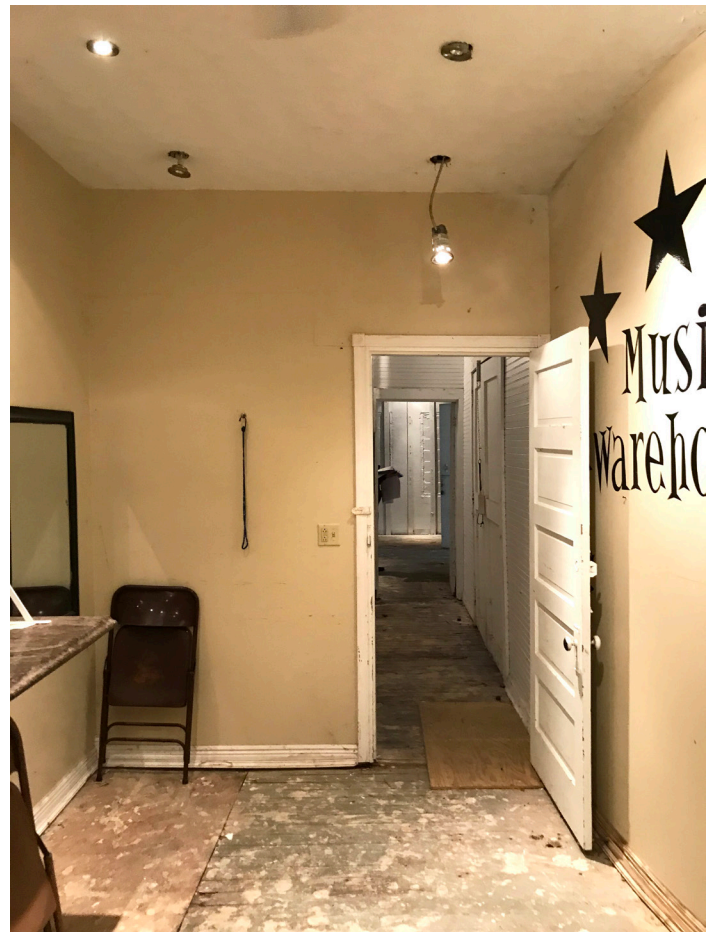
Existing walls have been finished with gypsum board over furring strips on masonry walls and due to space being unconditioned, the finish material has cut off natural air circulation leaving spaces with a damp/musty odor. The northeast and central rooms have had the gypsum board finish removed while, gypsum board finish remains in south west room. The existing flooring and floor support structure is in need of repair or replacement with areas where joists are deteriorated or missing. All existing doors and hardware are in poor condition and should be replaced including door to exterior from central room.

Remove existing flooring and floor structure and replace with new wood joists or concrete slab on grade with vapor barrier placed on ground below joists or under concrete slab. If new wood joists are installed, provisions for natural ventilation under floor is recommended. If new wall finishes are planned, it is recommended wood boards or sheathing be used and allow natural air flow in cavity created by furring strips at the perimeter wall. Other option is to remove furring strips, clean/repair masonry and paint masonry walls. It is also recommended to increase existing vent opening on upper portion of wall between the rooms.

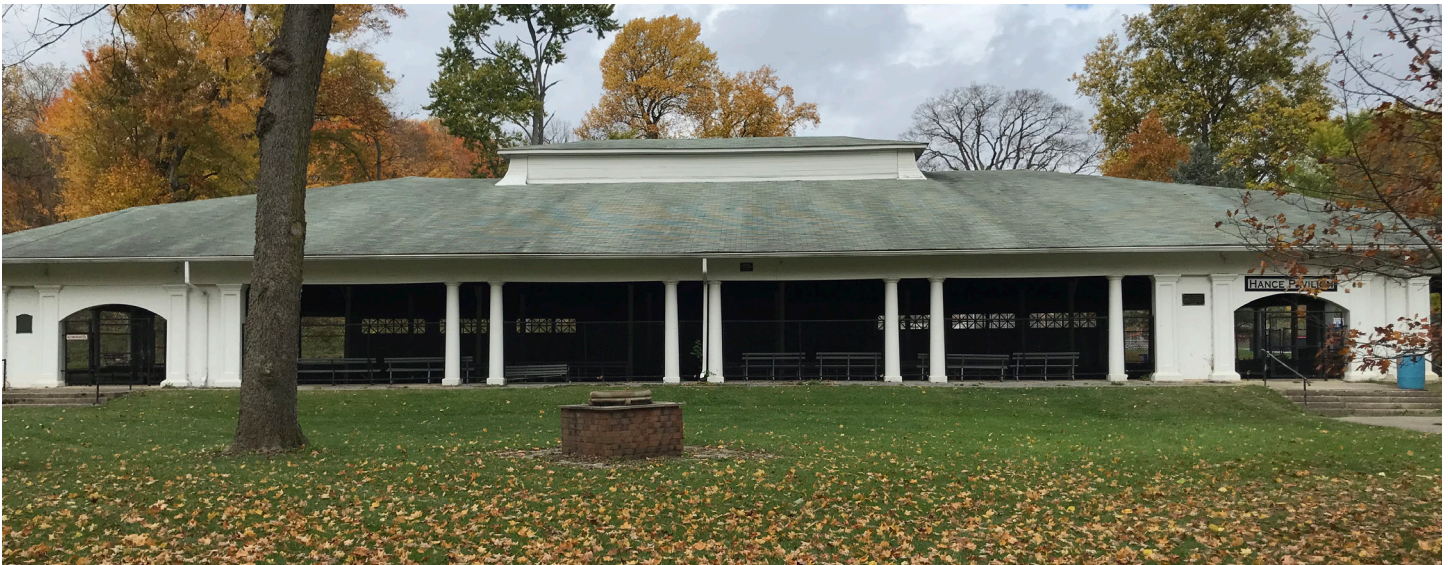
Original openings on cupola walls allowing ventilation and light to center of audience seating area have been closed in.

If funds are available, recreate openings in cupola and insert louvers or glazing in the openings.

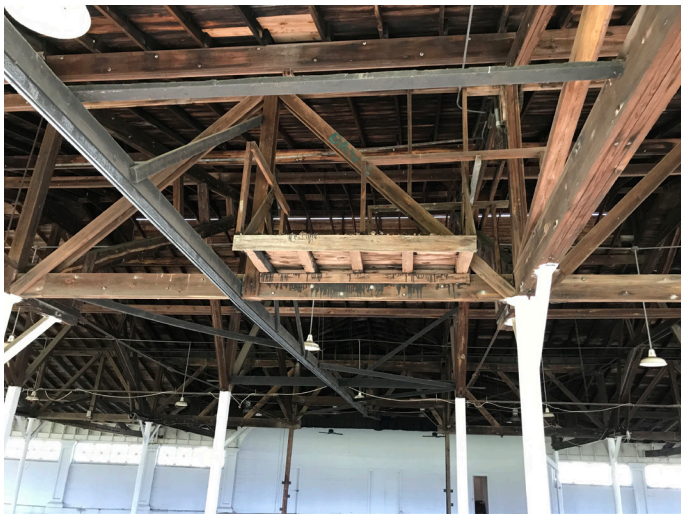
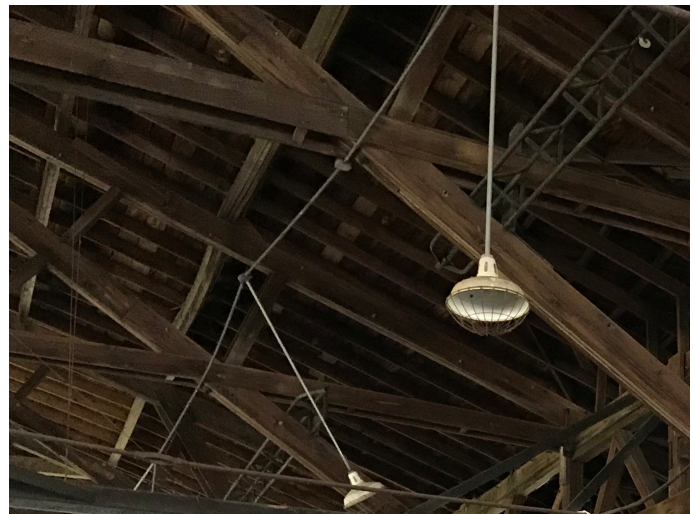
Existing lighting in the pavilion seating area consists of incandescent lighting based on 1978 drawings. This lighting system provides marginal lighting throughout the enclosed areas. In addition there is no emergency lighting or illuminated exit lighting in place at this time. Building exterior lighting is limited to a few incandescent floodlight type open lamp holders mounted to the outside structure above wall openings.

Replace entire pavilion lighting with new high efficiency LED fixture; including damp location style LED 'low bay' industrial style fixtures throughout the seating and audience areas, battery emergency lighting fixtures along egress paths, and battery exit light fixtures with outdoor remote heads at designated means of egress locations. In addition provide new LED exterior area lighting 'cutoff' style security lighting fixtures around building perimeter; with photocell or timer control. Depending on planned functions, the audience area LED fixtures could be configured to permit dimming for performance purposes.
