# CITY OF PIQUA, OHIO

## *Americans with Disabilities Act* **Self-Evaluation and Transition Plan**

**FINAL VERSION**

**NOVEMBER 2022**

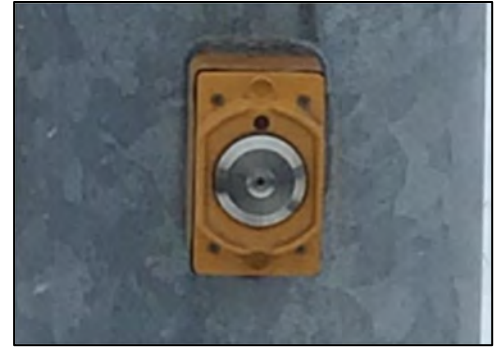
***Example of typical pushbutton that is 2" diameter but includes no tactile directional arrow on the pushbutton.***

- Adjust pushbuttons that require excessive force to operate and/or are above 48" height required.

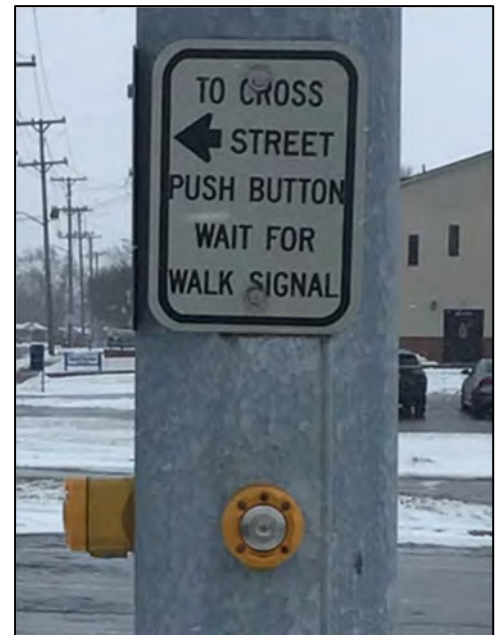
***Example of pushbuttons on shared pole with sign that includes visual text and arrow indicating the crossing direction controlled.***

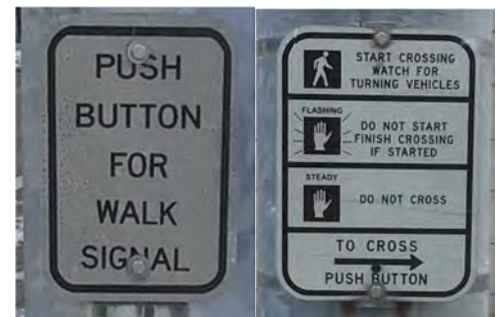
***Example of non-compliant signage that includes only visual text and fully compliant sign with text, arrow, instructions, and pictograms.***

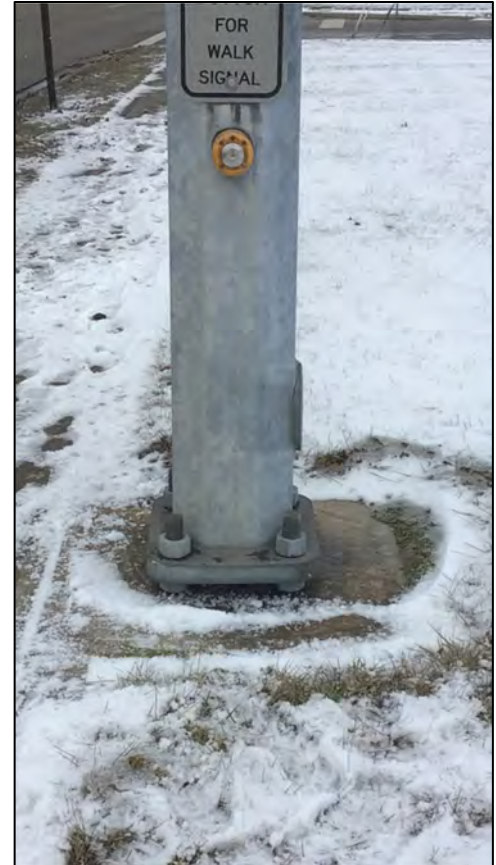
***Example of pushbutton that has clear space within a lawn area and not on a compliant accessible route.***

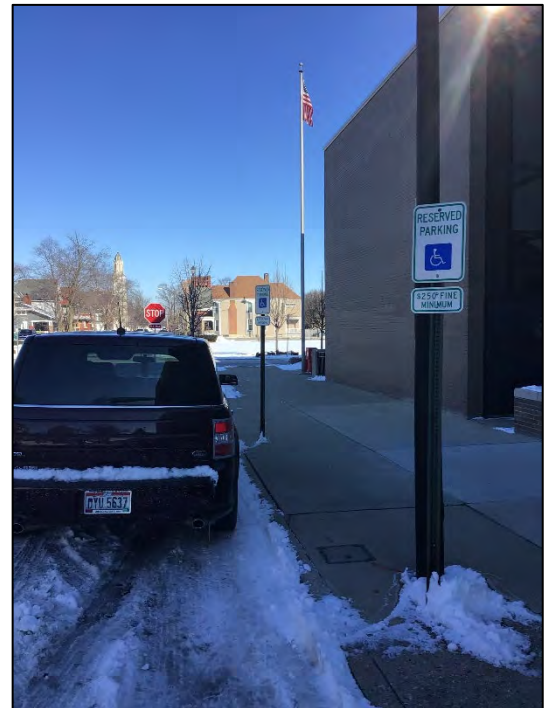
3. In several locations where parallel accessible spaces are provided, the space was not at the end of a block at an adjacent curb ramp (see Figure R309.2.2), or where angled accessible spaces were provided there was no access aisle adjacent to spaces and no curb ramp connecting the curb ramp to the sidewalk (see Figure

***Two accessible parking spaces adjacent to each other that utilize the corner curb ramp to access the PAR. Neither space is nearest the curb ramp (1 non-accessible space present) and both spaces require disabled drivers needing to use the ramp to access the PAR to travel a long distance near/within the vehicle travel lane.***

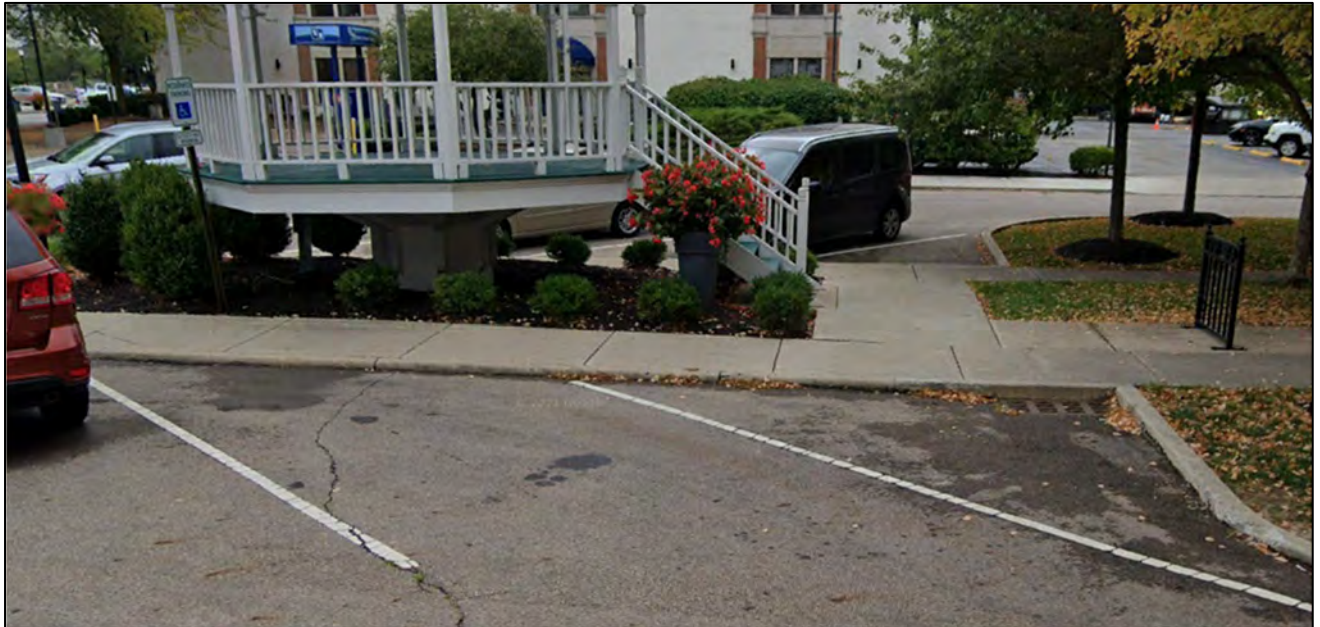
4. In locations where angled on-street parking spaces are provided, not all spaces provided an adjacent access aisle adjacent to the space or curb ramp to access the PAR from the access aisle.

***Angled on-street parking space with no compliant access aisle and no curb ramp available to access the PAR.***

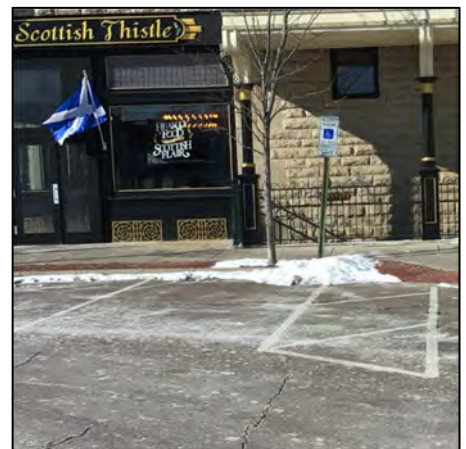
***Accessible on-street parking space with non-compliant width access aisle.***

An evaluation of existing non-compliant on-street parking is needed to determine the best means to achieve compliance with the number of accessible spaces provided, as well as providing compliant access aisles, curb ramps, proximity to curb ramps, and/or signage as applicable. In some locations where accessible spaces are “reserved”, they may be the only accessible space on that block and not provide the intended access to high use facilities. As noted in Section 2.9, consider providing signs to reserve these spaces for the applicant and provide a public accessible space elsewhere on the block if applicable. Consideration should be given to providing compliant signage for each space, particularly since accessible spaces cannot generally be adjacent to another accessible space and meet the provisions of R309.

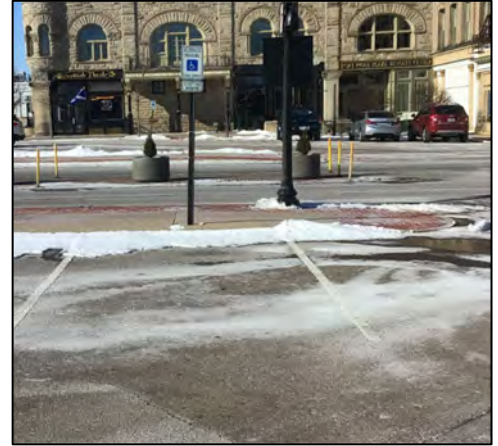
***Accessible on-street parking space with no access aisle.***

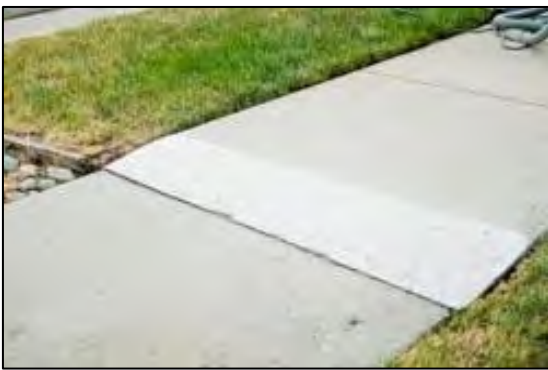
*Grinding of small displacements*

- Temporary placement of concrete or asphalt to ramp from adjacent panel where level changes are severe.
- Grinding the edge at surface level changes of up over  $\frac{1}{2}$ " to achieve allowable bevel.

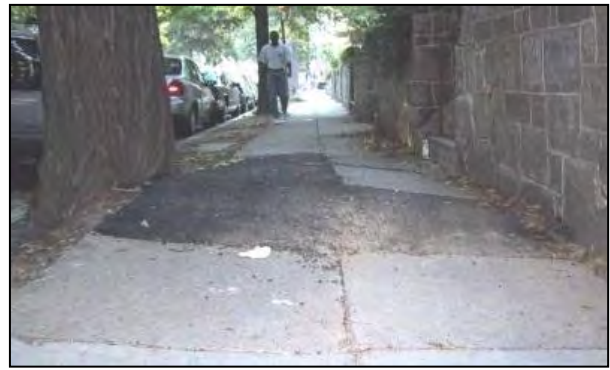
*Temporary patching for large displacements*

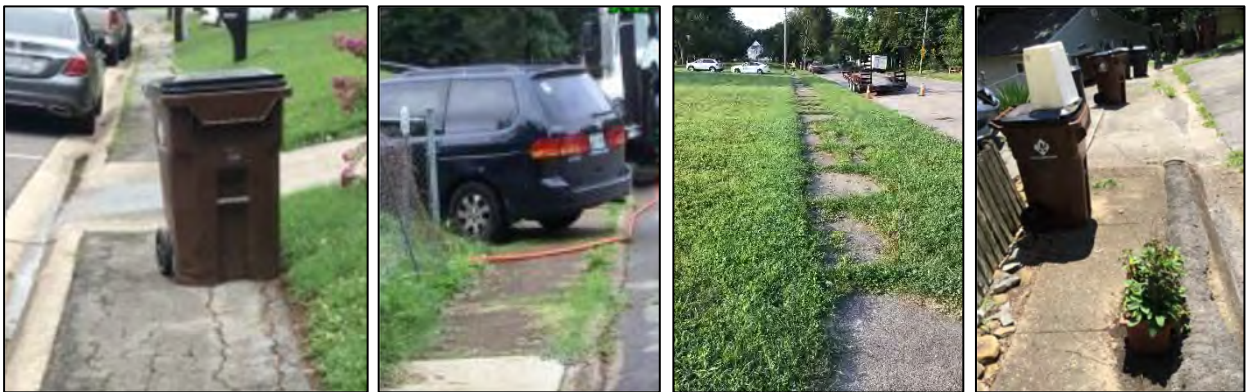
Obstructions typically include light and utility poles, newspaper and mailboxes, vegetation, signs, hydrants, and site furnishings. Other barriers include, but are not limited to, manholes, valve covers, open grate castings, and access boxes. These conflicts are generally classified as vertical displacements and slip hazards. There are limited areas where vehicles in parking lots abut the PAR. Some parking lots do not have curbing or bumper blocks that restrict the vehicles from overhanging the PAR and reducing it to less than 48" width. Obstructions can also be temporary in nature, including trash and recycling containers that are placed weekly at the curb on the PAR, cars in residential driveways, and chairs and tables for outdoor dining outside of businesses.

***Examples of temporary obstructions of the PAR that reduce the width to less than 48" (note these are not actual photographs in the City).***

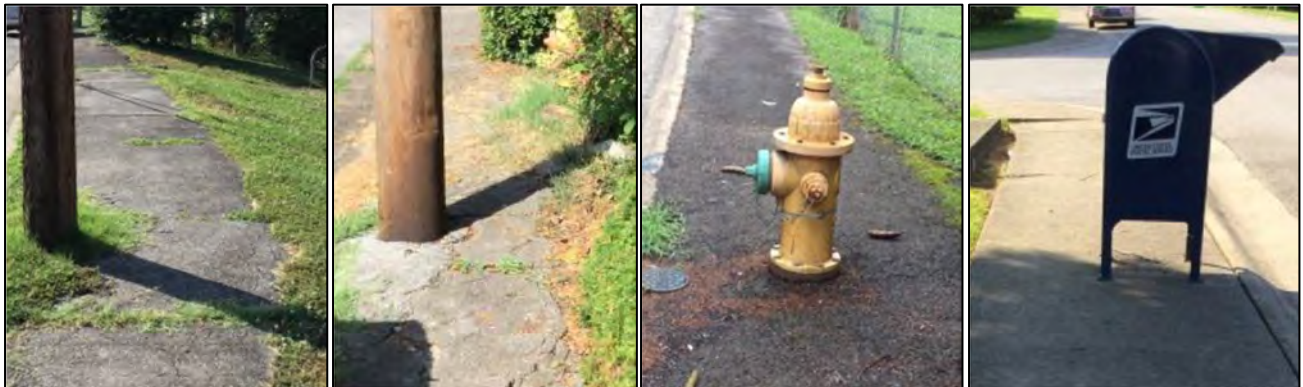
Fixed obstructions are a more difficult item to address and may be costly to address as they generally occur with utilities. Utility poles, guy wires, hydrants, and other structures that obstruct the ROW may require relocation or purchase of right-of-way from adjacent landowners. For all of these items, a work-around solution is often preferred and a less costly solution if ROW is available. These may include widening a small portion of sidewalk where possible or providing an equivalent alternate route. Providing a narrow area of tree lawn between the curb and sidewalk can assist by providing an area for items such as signs and mailboxes to be placed without obstructing the PAR and can also assist with resolving issues for temporary items like trash and recycling containers mentioned previously.

***Examples of more permanent obstructions of the PAR that reduce the width to less than 48" (note these are not actual photographs in the City).***

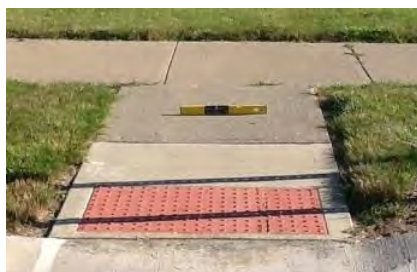
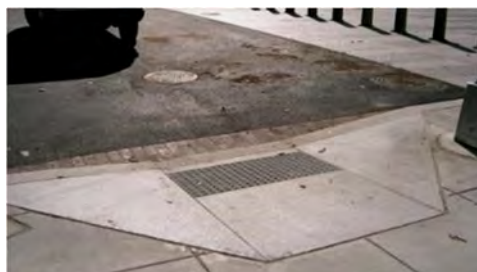
Perpendicular curb ramps have a running slope that cuts through or is built up to the curb at right angles or meets the gutter break at right angles where the curb is curved. The general direction of the curb ramp is perpendicular to the curb. Perpendicular curb ramps do not require edge delineation where the adjacent area is not part of the pedestrian circulation area (PCA) and is cane-detectable (e.g., turf). Where a PCA is adjacent on one or both sides, side flares are required.

**Examples of typical perpendicular curb ramps, with and without flares based on presence/absence of PCA.**

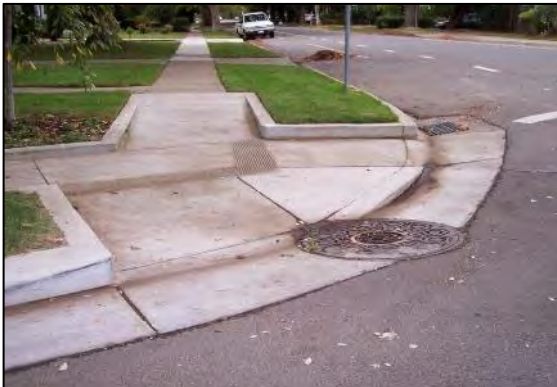
Parallel and perpendicular curb ramps can be combined and can be utilized where the sidewalk approaches are much higher in elevation than the street level at the intersection. A parallel curb ramp is often used to lower the sidewalk to a mid-landing/turning space and a short perpendicular curb ramp connects the landing to the street. Combination curb ramps can be provided where the sidewalk is at least 6.0 feet wide and can provide access in situations where the sidewalk is much higher than 6" above the street elevation.

*Example combination curb ramp, with a perpendicular ramp to a common landing and adjacent parallel ramps.*

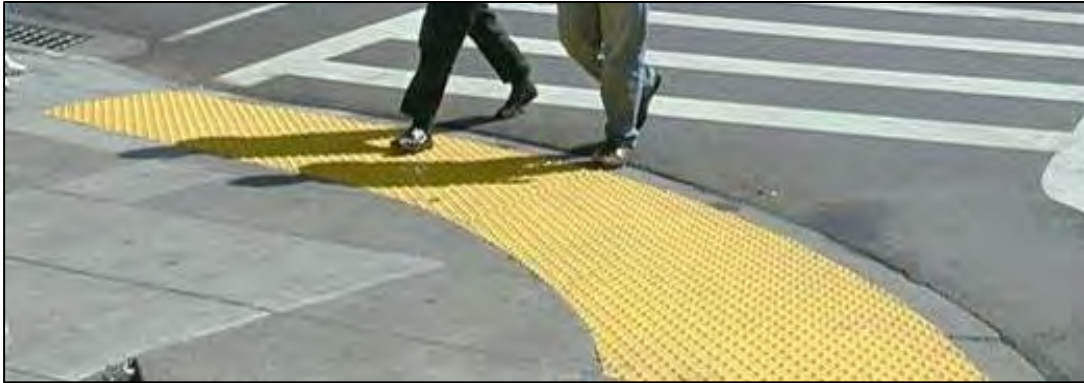
Blended transitions are raised pedestrian street crossings, depressed corners, or similar connections between pedestrian access routes at the level of the sidewalk and the level of the pedestrian street crossing that have a grade of 5 percent or less. Blended transitions are suitable for a range of sidewalk conditions. In many locations, particularly in downtown business districts, diagonal blended transitions were commonly used where there were subtle differences between the PAR and adjacent roadway at intersections. As discussed below, diagonal curb ramps/blended transitions are no longer allowed per PROWAG except under unusual conditions.

***Diagonal blended transition. Note the level transition from the street crossing to the PAR.***

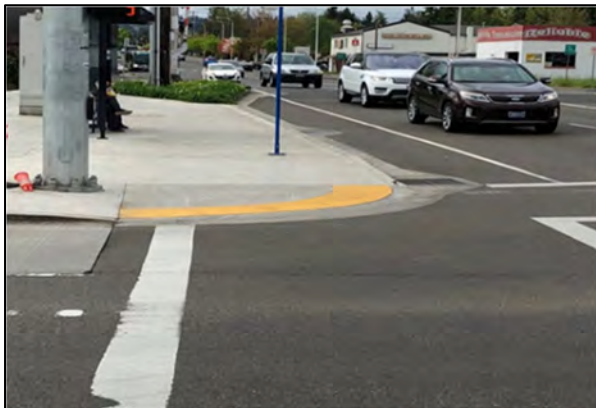
A very common type of curb ramp, including many in the City, are diagonal curb ramps. Diagonal curb ramps can be either perpendicular or blended transitions (sometimes called depressed corners). Regardless of the type, diagonal curb ramps provide access to multiple directions of street crossings. Per R207.1 of PROWAG, two ramps are typically required at each corner. Diagonal curb ramps are not the preferred method of construction due to lack of directional cues for pedestrians using the crossing and safety concerns created by vehicles misconstruing pedestrian intentions. Per R207.2, where existing physical constraints prevent compliance with R207.1, a single diagonal curb ramp shall be permitted to serve both pedestrian street crossings.

***Diagonal blended transition (left) and diagonal perpendicular ramp (right). Both provide access to street crossings of more than one direction and are permitted by PROWAG R207.1 only in certain locations.***

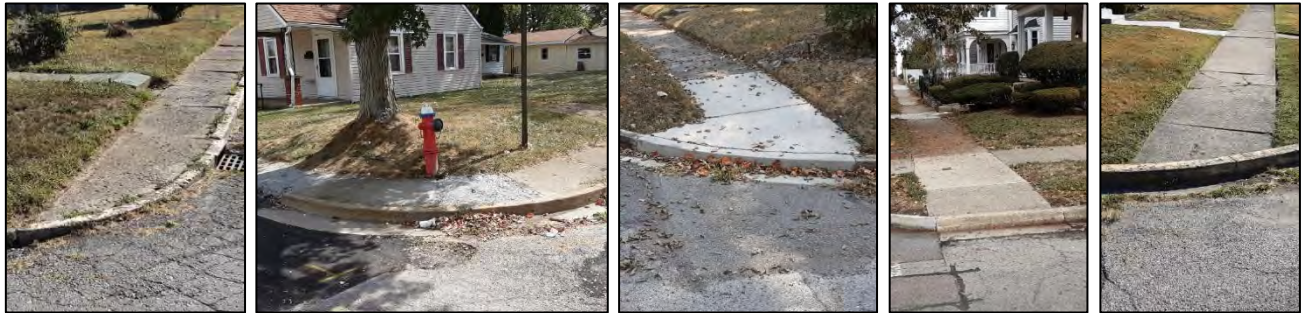
*Examples of locations with PAR provided but no curb ramp is provided.*

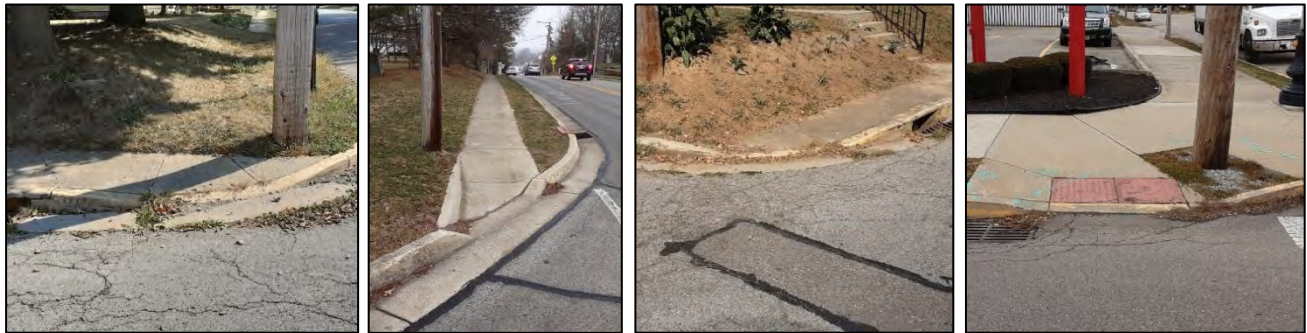
*Examples of curb ramps that are less than the minimum 48" width required.*

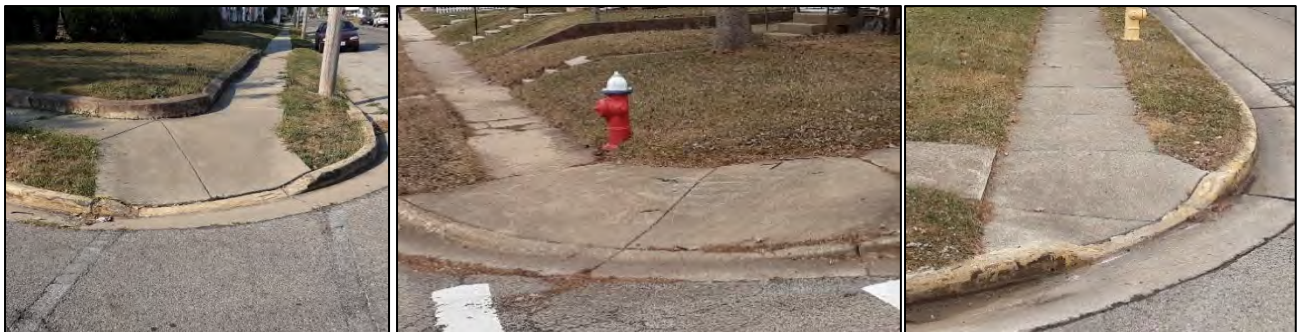
The number of ramps that were not in compliance with the 8.33% maximum running slope was relatively small (over 120). To provide a compliant 8.33% maximum running slope for a perpendicular ramp for a typical 6" curb, the distance required from the grade break to the top of the ramp is 6 feet minimum, at which point a minimum 48" top landing is required. In many areas the running slope complies but there is no landing or TS provided because of the lack of depth.

***Curb ramps with excessive running slopes, typically severe slopes that exceed 10%. These ramps also exceed the counter slope requirements.***

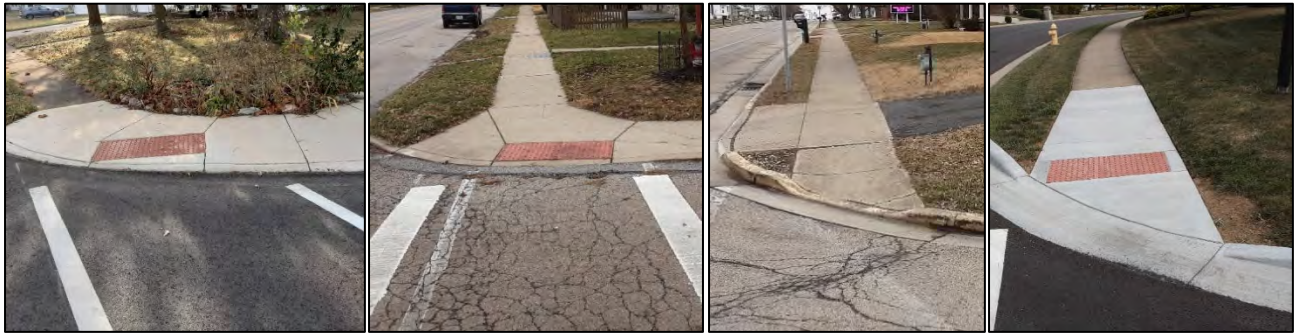
Within the City, there were a large number (over 940) of curb ramps with cross slopes over 2%. Some are minor deviations that do not affect the usability, though many of these have other issues not related to ramp cross slope that present a barrier to access.

*Curb ramps with excessive cross slopes. These ramps also typically have non-compliant landing cross slope.*

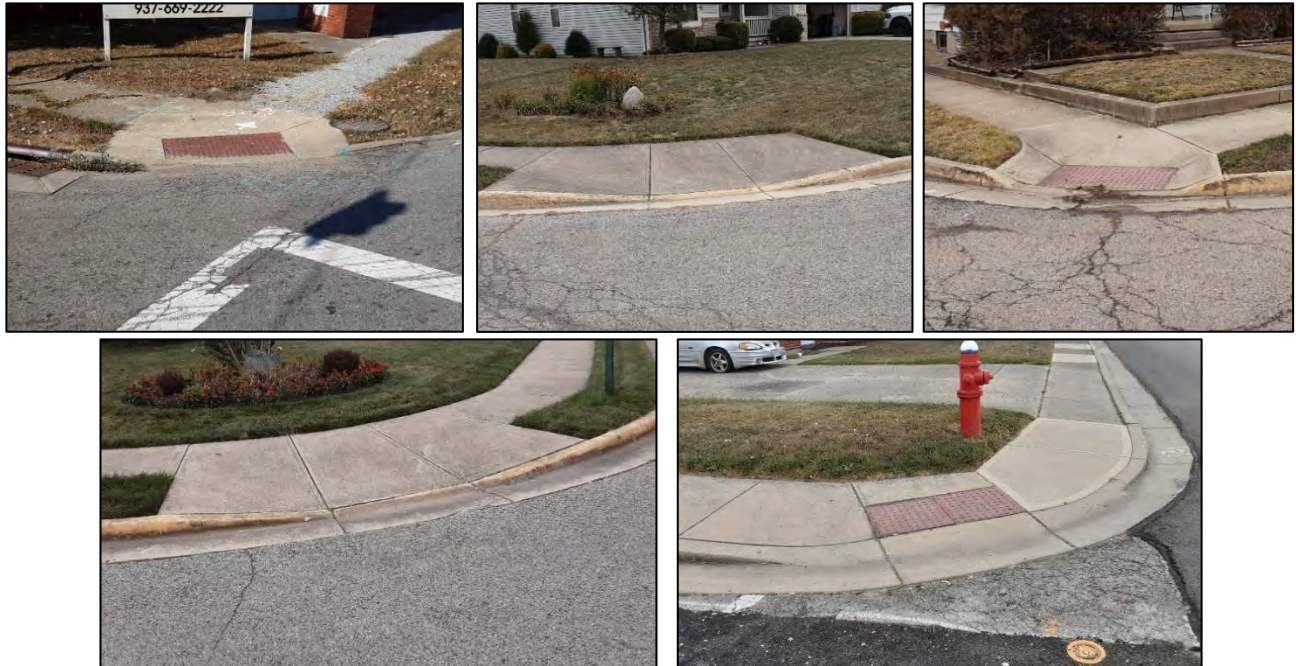
Within the City, there are a high number of primarily perpendicular curb ramps that do not provide compliant turning spaces (over 940 with slope and/or dimensional issues). These locations typically are located where there is not adequate room to construct a perpendicular ramp and results in no turning space being provided. Wheelchair users attempting to use these ramps would be in danger of tipping over when attempting to turn. This was the most prevalent high priority issues to address with curb ramps in the City. As illustrated in the examples shown, curb ramps with non-compliant turning spaces often have other non-compliance issues. Parallel ramps with non-compliant turning spaces were often highly usable.

*Example of curb ramps that lack a compliant turning space.*

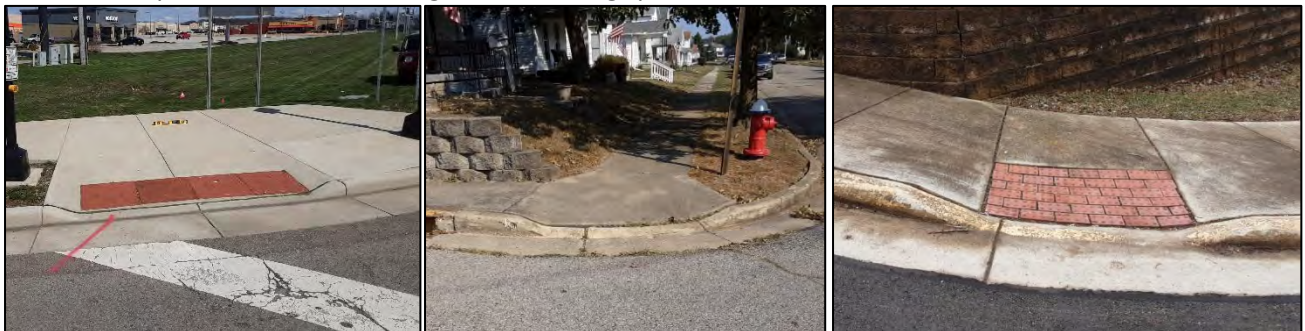
- Many locations did not require a flared side. A majority of sidewalks in the City have at least a small tree lawn in residential areas. Within the downtown, most sidewalks are located immediately adjacent to the curb or street.
- A low number of perpendicular curb ramps (approximately 300) that require 10% maximum flares that far exceeded the standard. The flares that were present were often a rolled curb that exceeded 25% slope. These severe slopes are trip hazards in the PCA. In some locations, there are other more severe non-compliance issues, including lack of turning spaces.

*Example of curb ramps that have non-compliant flare slopes.*

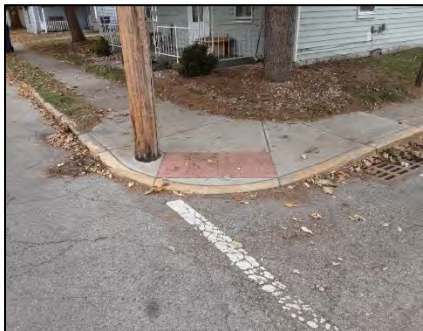
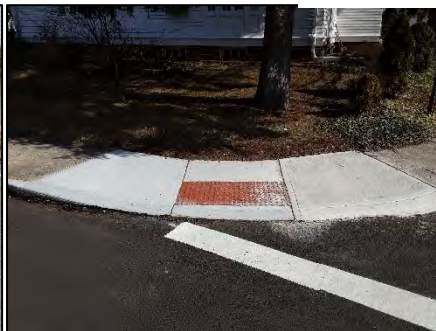
**Example of curb ramps that have no clear space or clear space is not within crosswalk.**

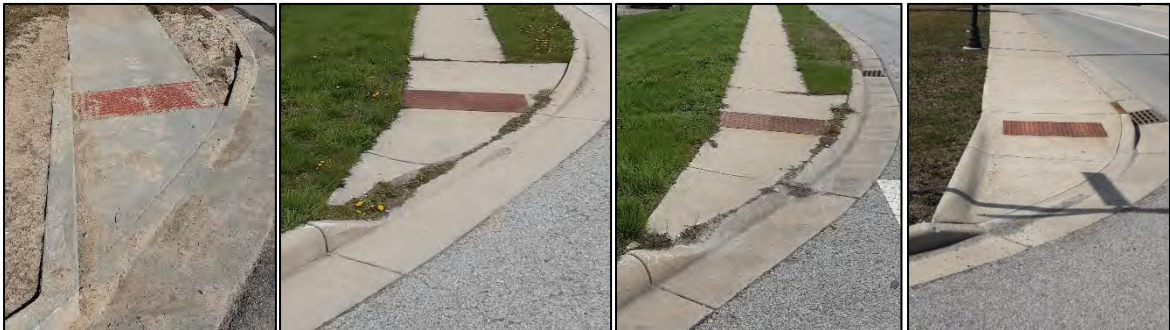
*Example of blended transitions with detectable warnings further than 5' from the curb on 1 or more sides.*

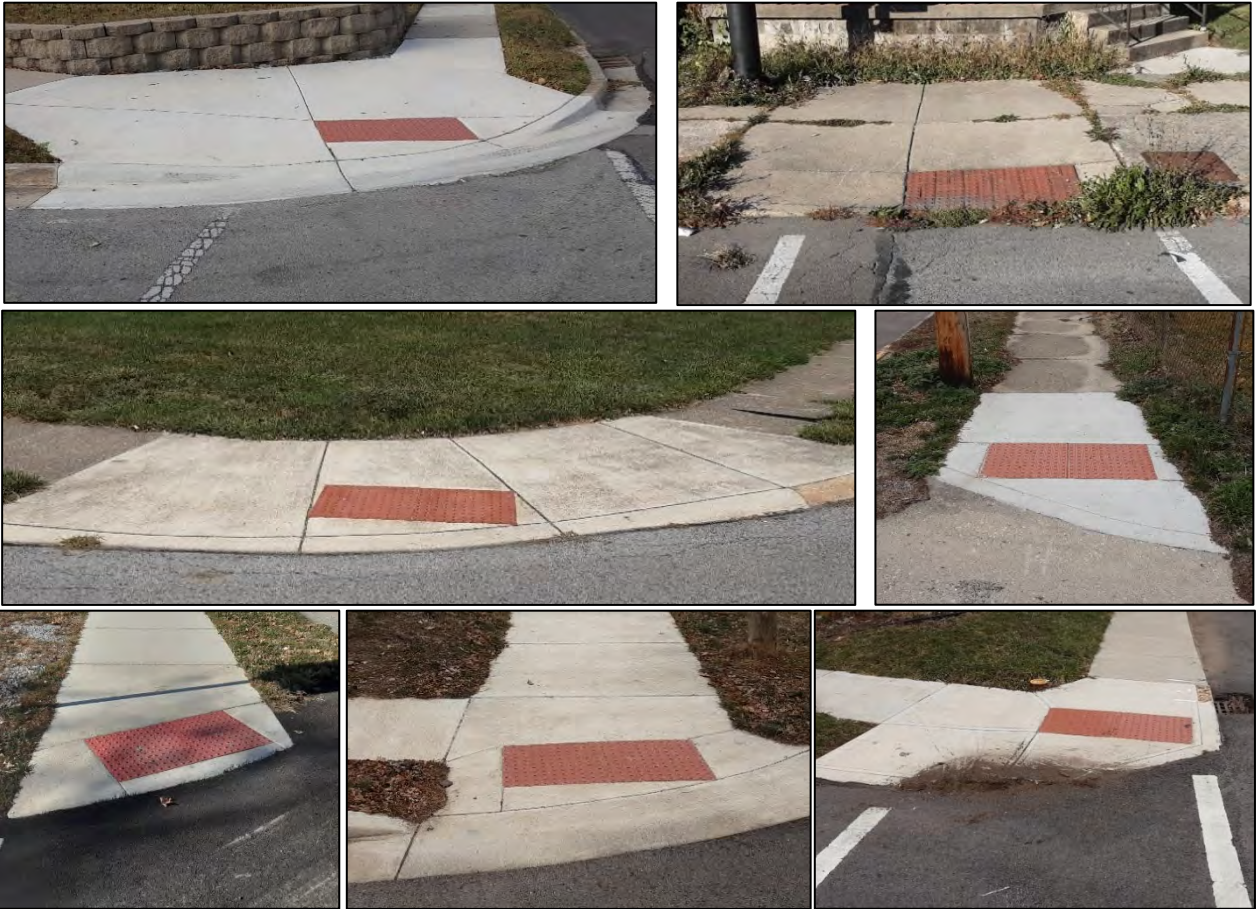
***Example of curb ramps with detectable warnings that are not full width of the ramp.***

In many cases, curb ramps with non-compliant or missing DWs have other issues that cannot be easily addressed without reconstruction. Retrofit DW kits are available for use on ramps where all other criteria are compliant and should be considered for use in these locations. Some non-compliant locations with high pedestrian volumes or known blind pedestrian users should be considered for these retrofit kits until the ramp can be corrected entirely. For locations where the DW does not extend full width or required 24" depth, they can be removed and replaced along with any concrete damaged by the operation. For all future DW installations, steel, HDPE, or cast iron products that provide greater durability for the truncated domes are recommended. Using these products in lieu of a brick or cast concrete panel may minimize plow damage and wear of truncated domes.

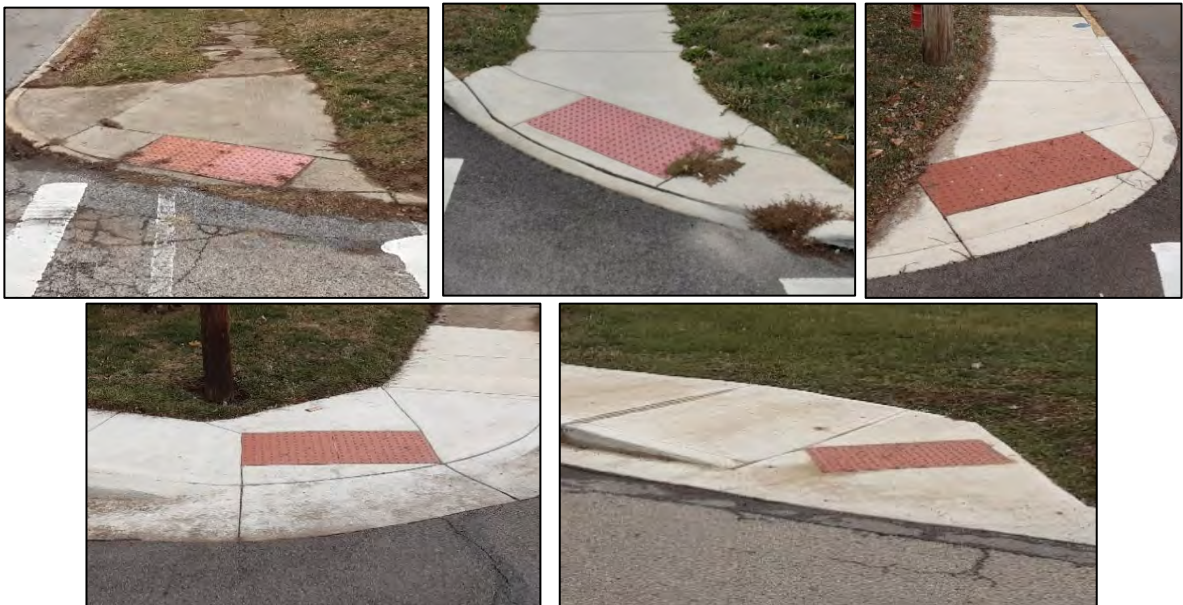
***DWs that are oriented poorly and are not 24" depth in entire direction of pedestrian movement.***

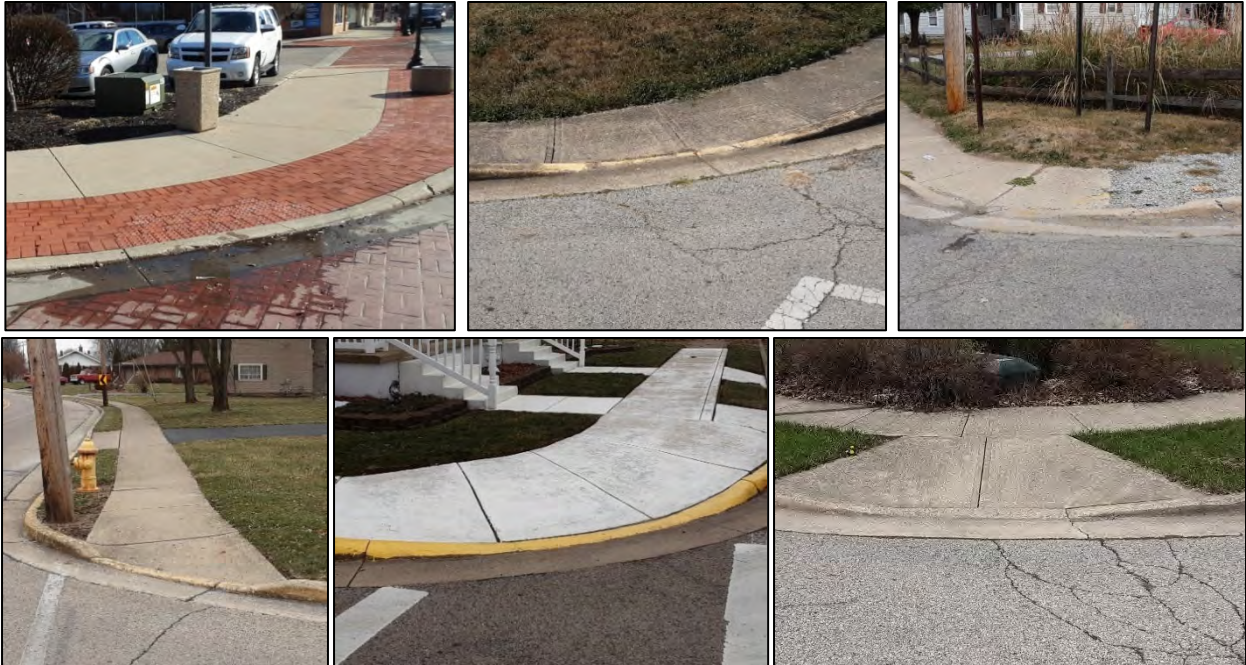
***Curb ramps lacking DWs as required or which have low contrast.***

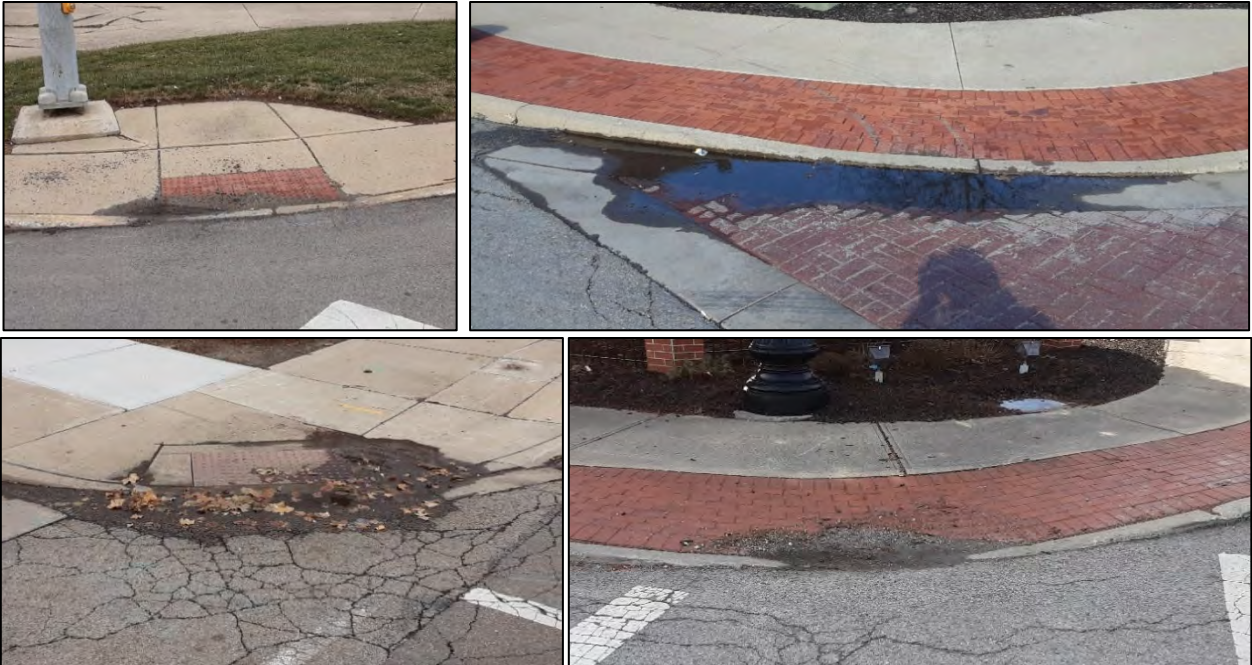
The self-evaluation noted a number of locations with either standing water within the curb ramp at the time of the evaluation or deposits of sediment, indicating that standing water is common. In some cases, the poor drainage is a result of changes to the low point in the gutter from an asphalt overlay. In others, drainage was either not considered adequately during design of the roadway or was not constructed according to the plans.

**Examples of curb ramps with drainage issues and/or evidence of regular ponding, with sediment deposition.**

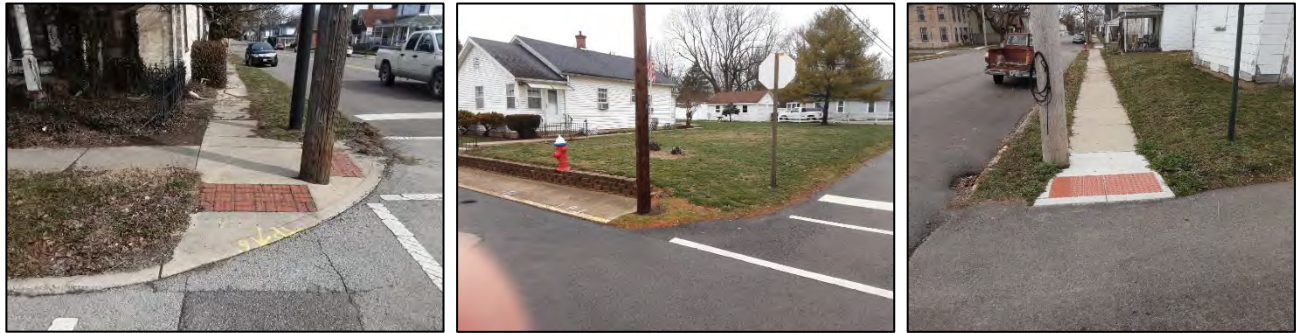
**Examples of curb ramps with obstructions at turning spaces, on the ramp, or immediately adjacent to either.**

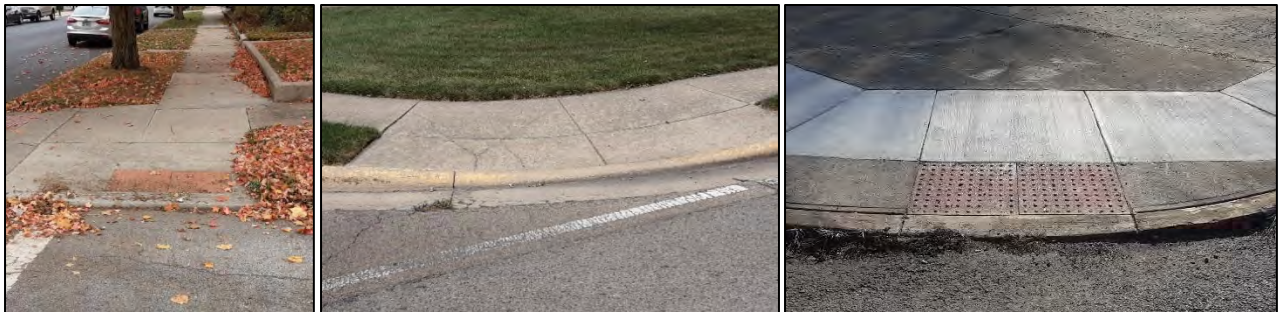
**Examples of curb ramps with vertical discontinuities that exceed 1/2" at the curb, on the ramp, or the TS.**

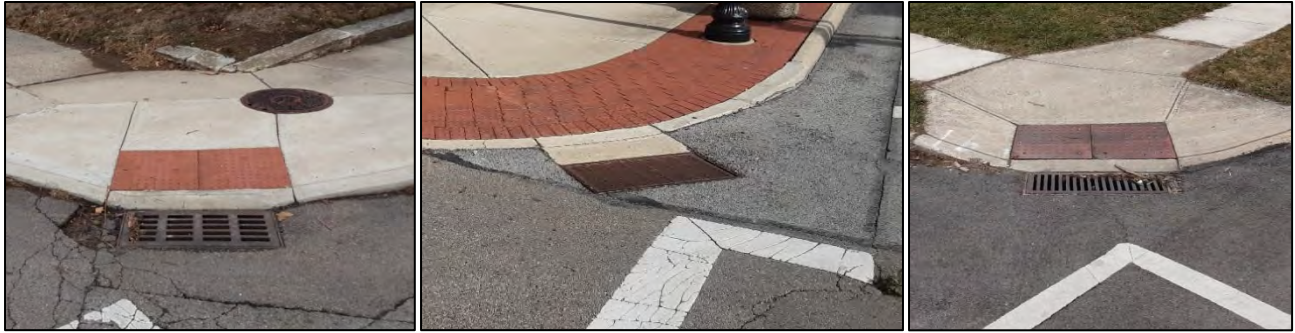
*Examples of curb ramps with utility structures on the ramp or the clear space.*

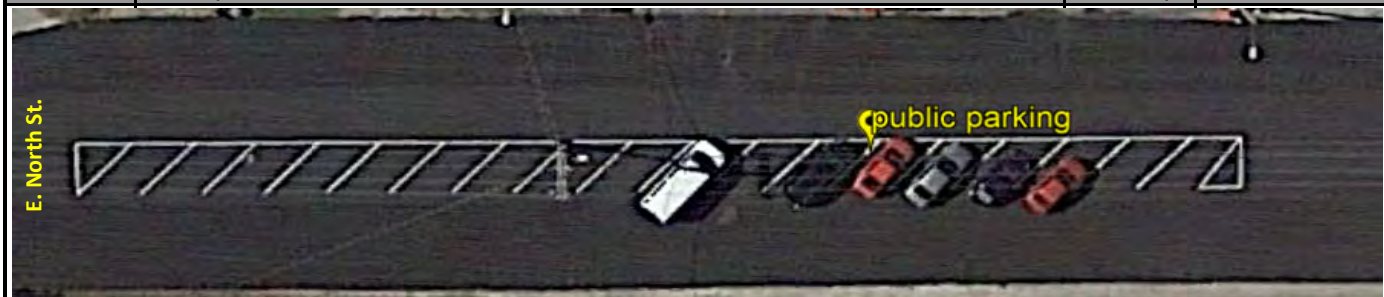
### Canal Parking Lot - North of E. North Street/East of N. Main Street

| Item # | Description | Priority | Probable Cost |
|---|---|---|---|
| | NOTE: There are a total of 17 spaces in the lot, including 0 accessible. A total of 1 accessible spaces (including 1 van) is required. | | |

| Item # | Description | Priority | Probable Cost |
|---|---|---|---|
| | Notes: This lot is isolated and located north of the downtown shopping area. There are no accessible spaces provided. Provide min. 1 van-accessible space or consider locating the required space for this lot elsewhere within the downtown where use would be higher and more beneficial per 208.3.1 Exception 2. Cost for signage and pavement markings is similar regardless of location.<br>Federal Guideline: 208, 502 | | |

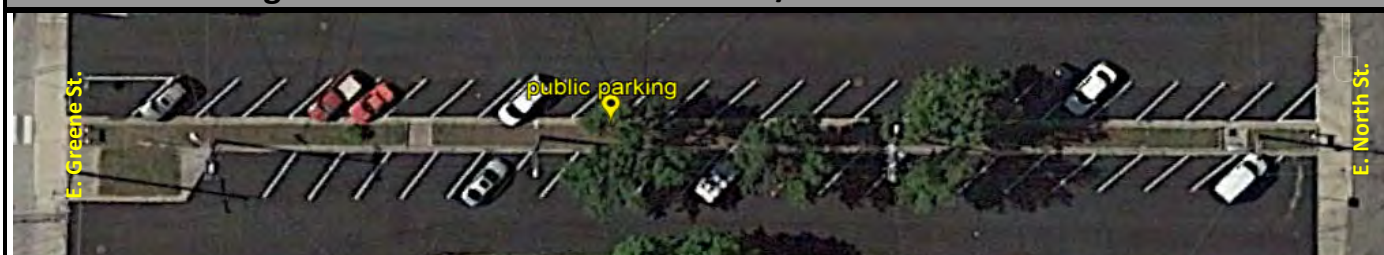
### Canal Parking Lots - North of E. Greene Street/East of N. Main Street

| Item # | Description | Priority | Probable Cost |
|---|---|---|---|
| | Notes: The accessible space provided has no van sign and the pavement markings were faded. Provide van sign and pavement markings.<br>Federal Guideline: 208, 502 | | |

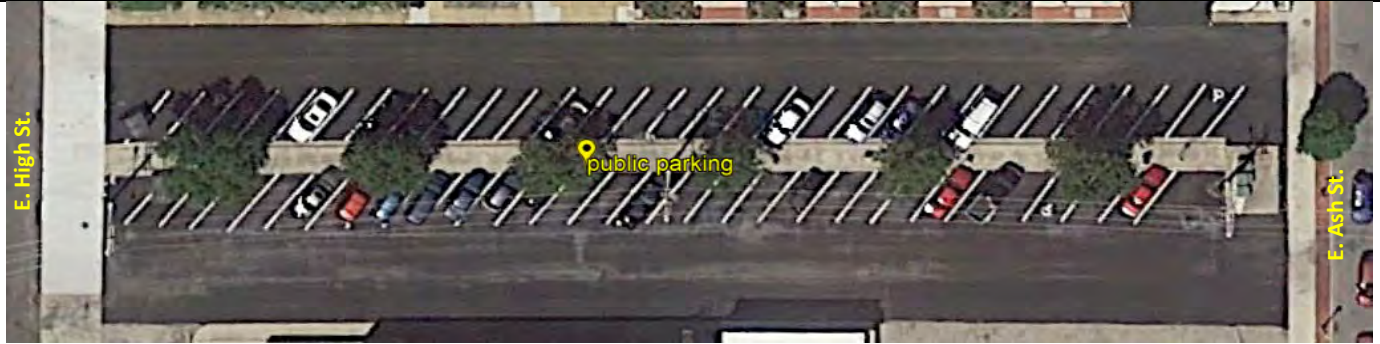
| Item # | Description | Priority | Probable Cost |
|---|---|---|---|
| | Notes: The accessible space provided has no van sign and there is no access aisle provided. Provide van sign and pavement markings for access aisle at location with compliant cross slopes and dimensions.<br>Federal Guideline: 208, 502 | | |

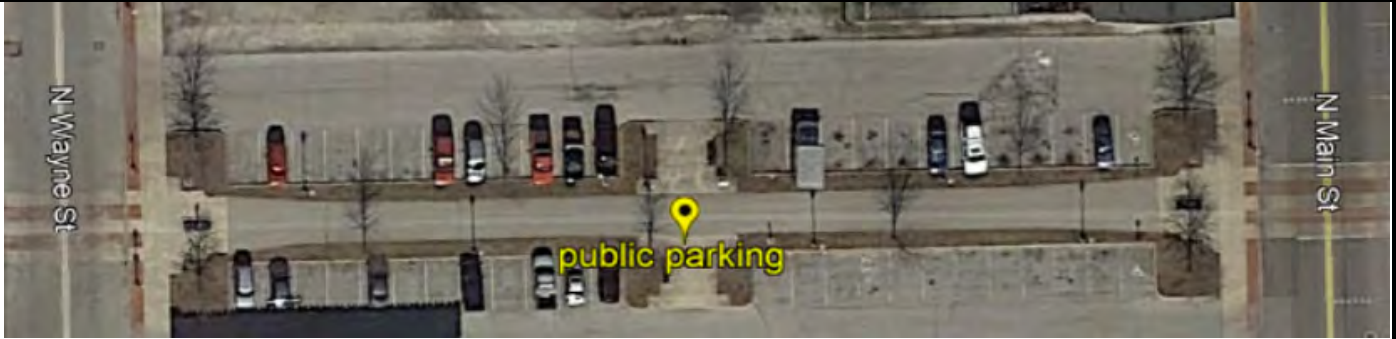
| Item # | Description | Priority | Probable Cost |
|---|---|---|---|
| | Notes: This lot is located immediately adjacent to the greenway. The existing accessible space does not include a van-accessible sign or access aisle and the existing sign bottom is at 47-1/2" (60" min. req'd.). Provide compliant dimensioned access aisle, also adding a van tag and raising the height of the existing sign to min. 60" to the bottom of the lowest sign on the post.<br>Federal Guideline: 208, 502 | | |

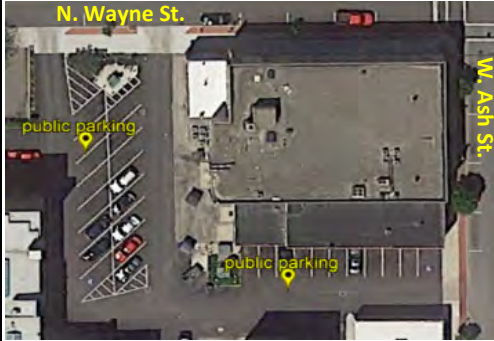
| Item # | Description | Priority | Probable Cost |
|---|---|---|---|
| | <p>Notes: No van-accessible space provided, neither existing space has a compliant access aisle (existing space off N. Wayne St. is not compliant for full depth), and only 1 space has signage. Provide min. 2 accessible spaces with signage and compliant dimensioned and sloped access aisle, including 1 van-accessible space. Consider locating space in lot off N. Wayne St. to public ROW sidewalk. Cost is for 1 sign, including 1 van sign and pavement markings for access aisles.</p> <p>Federal Guideline: 208, 502</p> | | |

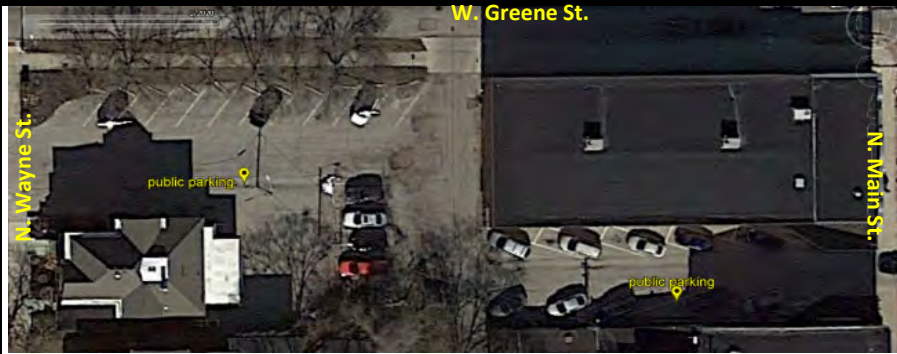
| Item # | Description | Priority | Probable Cost |
|---|---|---|---|
| | Notes: No van-accessible space provided and existing space has no access aisle. Provide min. 2 accessible spaces with signage and compliant dimensioned and sloped access aisle, including 1 van-accessible space. Consider locating space in lot off W. Greene St. to public ROW sidewalk. Cost is for 1 new sign and post, 1 van sign, and pavement markings for access aisles.<br>Federal Guideline: 208, 502 | | |
