HANCE PAVILION ASSESSMENT FOR CITY OF PIQUA

May 19, 2023

FREYTAG & ASSOCIATES INC.
ARCHITECTS ENGINEERS

Executive Summary

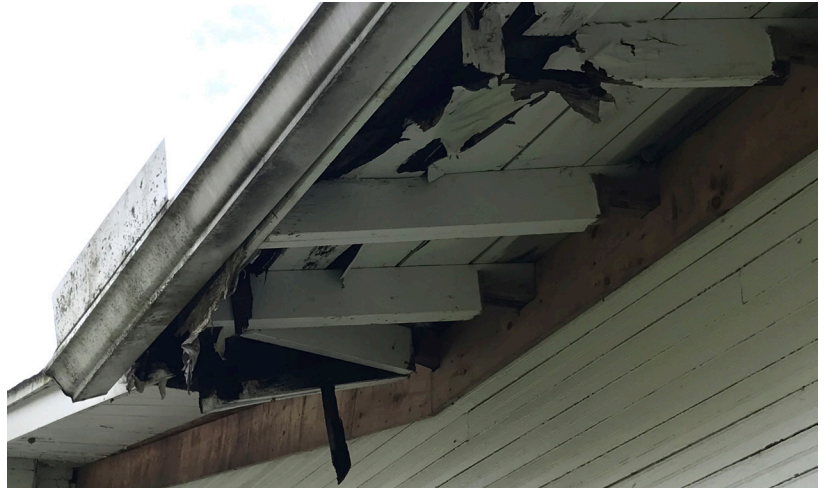
Existing roof over the main structure consists of asphalt shingles over wood sheathing/wood structure over audience seating/stage and EPDM roofing over wood sheathing/wood structure above dressing rooms. The original roof covering over dressing rooms appears to have been a built up roof as evidenced on parapet walls. Both roof coverings are in poor condition and in need of replacement. Major deterioration has occurred at shingle roof over the low slope roof, areas A and B, on Roof Plan diagram. The wood sheathing in several areas appears to be deteriorated and for purposes of this report it is assumed 10% of the sheathing will be replaced. Existing gutter and downspouts are in poor condition and need to be removed and replaced. Masonry parapet wall has clay coping tile and is in fair condition.

Remove all existing roof coverings and deteriorated sheathing. Provide new sheathing, underlayment and new asphalt shingle roof over the main structure and clerestory. In low slope portion of the roof, areas A and B, provide adhered EPDM roof covering. Above dressing rooms, area C, provide new sheathing and adhered EPDM roof covering including flashing on parapet walls and new metal coping. Provide new metal gutter and downspout around perimeter of the structure. with downspouts to outlet directly in grass area.
